Heating

Building Inspection Report

Inspection Date:
06/12/2013

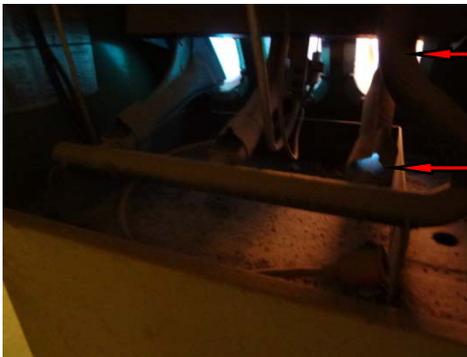
Furnace

- **Deferred Cost Item:** Unable to determine the age of the gas back up furnace, but it is an older unit and it may be near the end of its useful life. You should reserve funds to be ready to purchase a new furnace.
- **Monitor:** The wood stove is said to be around 30 years old, but has not been used much until the last 5 or so years. A hot fire was going during the inspection preventing inside of stove from being examined closely.
- **Repair:** The heating system requires service. The right hand burner did not burn properly at first and a gas smell was noted when the cover was first removed. Annual service by a qualified HVAC technician is recommended.

Flame yellow instead of blue.

Burning into the back side of burner.

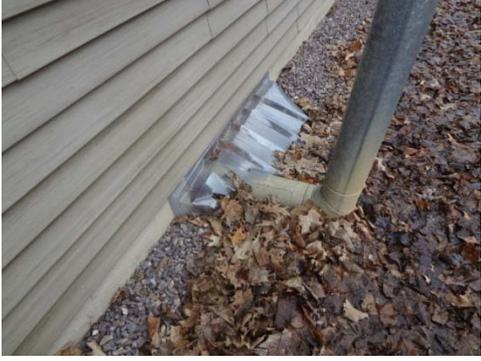
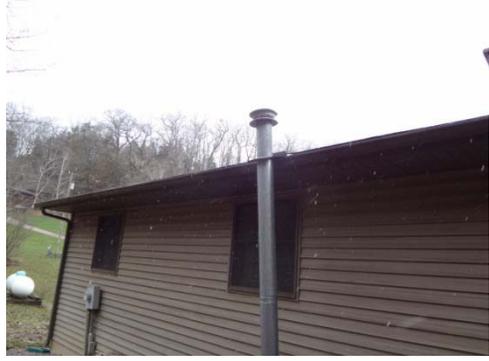
Combustion / Exhaust

- **Repair, Possible Safety Issue:** The vent for the water heater and gas furnace goes through a window pane that has been removed and replaced with metal. Then it goes to the edge of the roof line, but does not extend above the roof peak as recommended. This condition should be evaluated and corrected as needed by a qualified heating technician.
