# *Top Choice Home Inspections, LLC*

## Property Inspection Report

Sample , Richland Center , WI 53581

Date of Inspection: 1/14/2014 Time: 9:00 a.m.

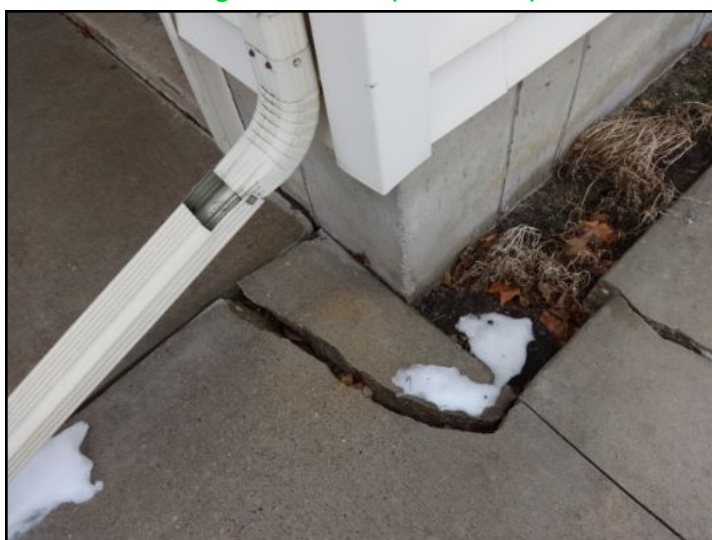
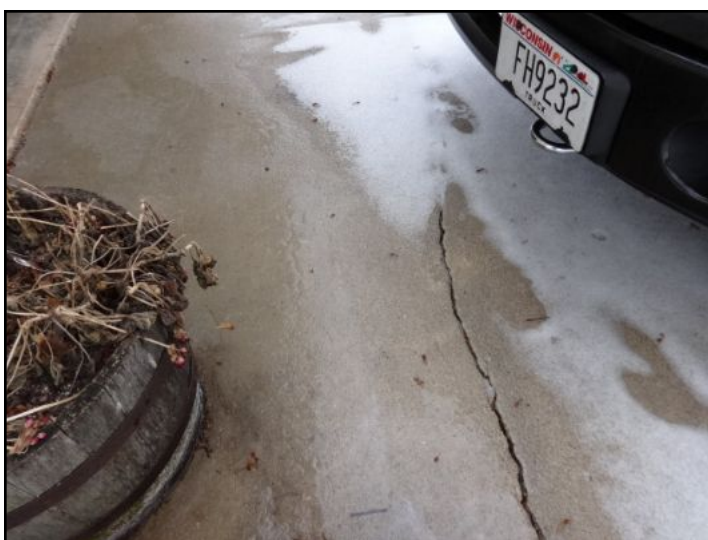
- Cracks were noted in the walkway. Recommend monitoring. If cracks become large enough to be a trip area, repair is recommended.
- Cracks were noted in the driveway. Recommend monitoring. If cracks become large enough to be a trip area, repair is recommended.

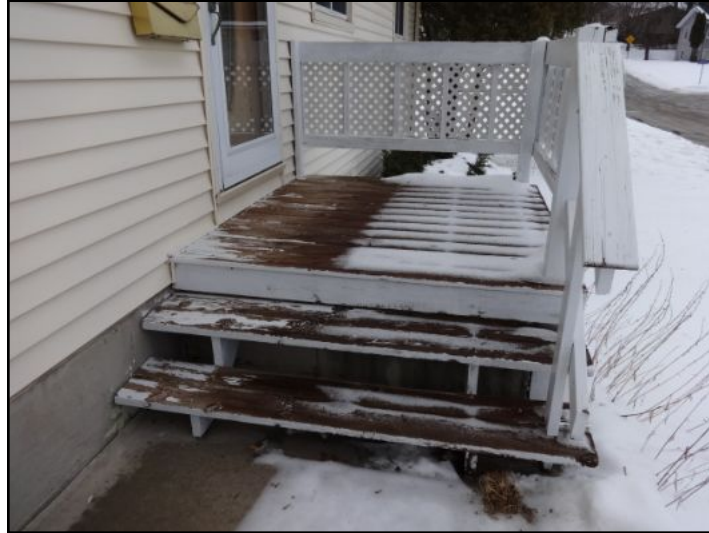
- **MAINTENANCE:** Whether treated or not it is important to keep a wooden deck free of all forms of fungal growth and/or debris that retains moisture and could promote rot. Recommend cleaning when needed and sealing or staining the deck as needed, possibly annually.
- Rot/deterioration was noted. Recommend identifying and eliminating any moisture source and repairing or replacing any damaged areas and sealing or staining as needed.

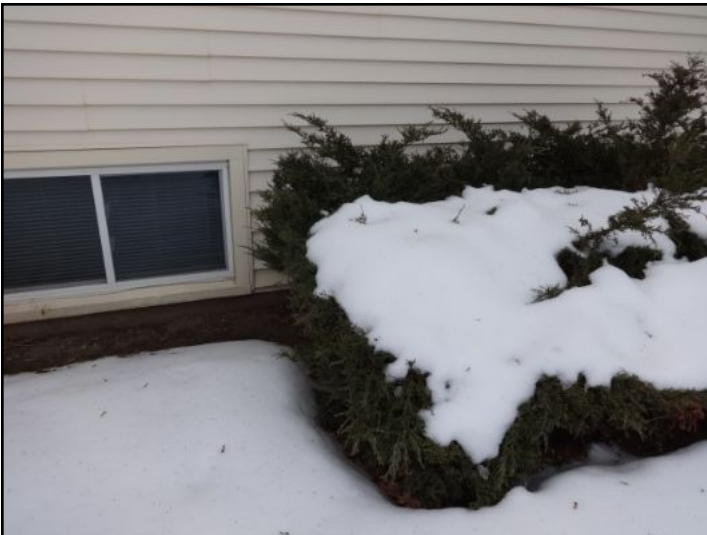
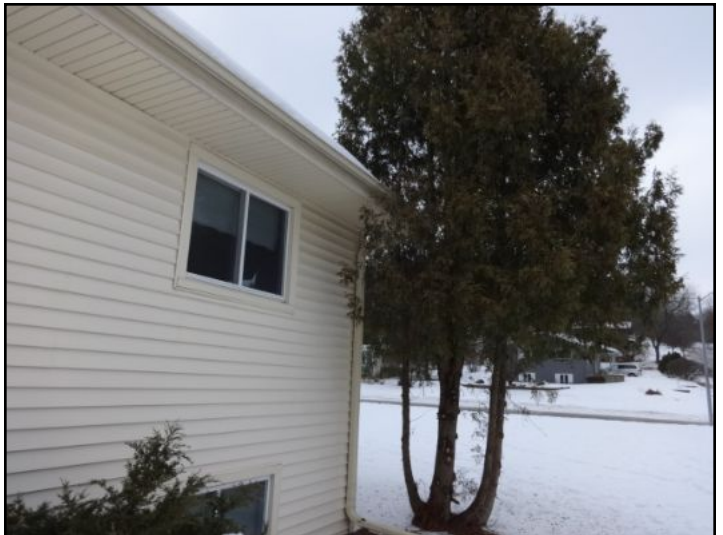
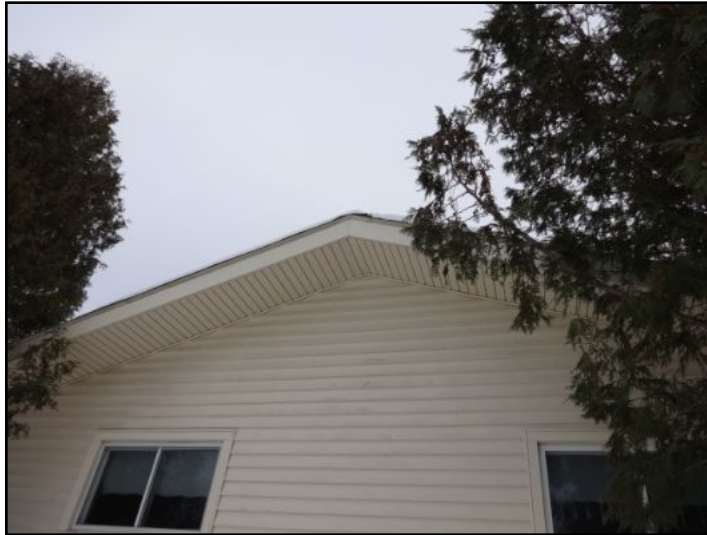
- Recommend tree branches and vegetation are kept trimmed away from the house. Vegetation can hold excess moisture against the house, possibly causing damage to the sheathing below the siding and/or making a pathway for insects. Tree branches can deposit debris on the roof which can shorten roof covering life or cause physical damage to the roof. This will be a recurring maintenance item.

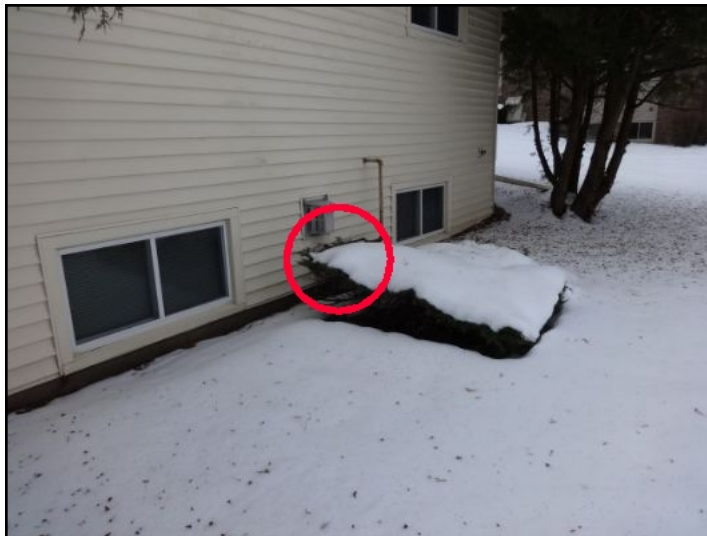
Valve Location: Natural gas shut off is located at the outside meter. • North side.

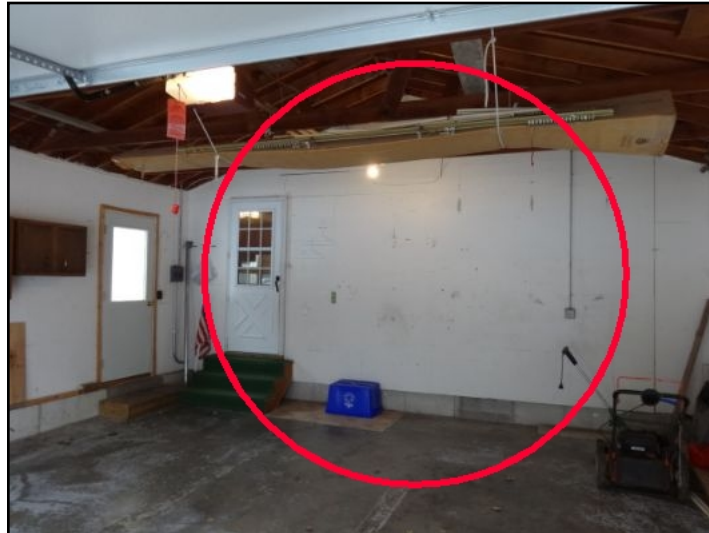
• While a house is to be built to the standards in place at the time of construction, recommend considering upgrading to more current fire separation practices. An example of typical fire separation of today would include 5/8" fire rated (type X) drywall with at least 1 coat of drywall compound on all seams and screw/nail heads on any wall or ceiling between the garage and living area and a fire rated door and door frame.

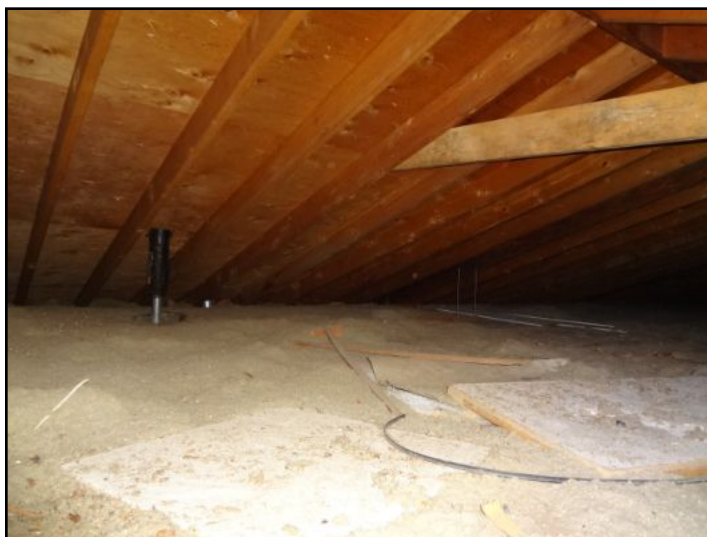
Depth: Insulation averages approximately 4"-6"

• Recommend considering the addition of more insulation. Check local standards for insulation requirements in new construction if interested, but standard energy efficiency is reported to be at least R-50 and high energy efficiency is reported to be at least R-60 in the attic.

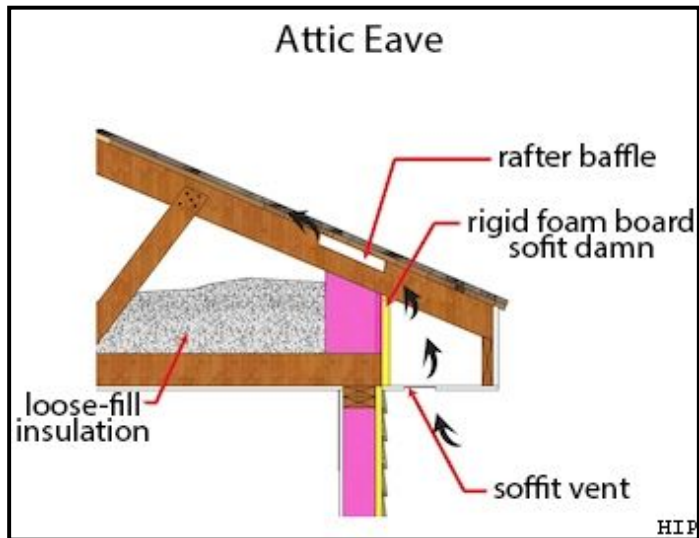
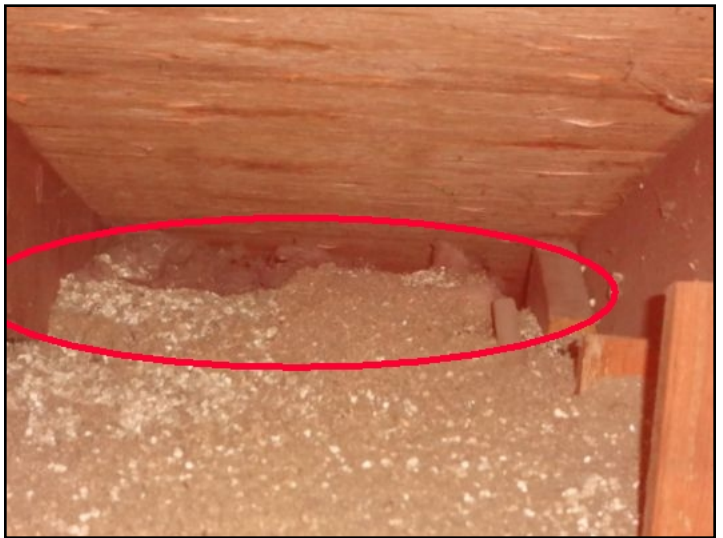
• The air passage between the soffit vent and attic space appears blocked. Recommend using a baffle (often called proper venting) to hold the space open.

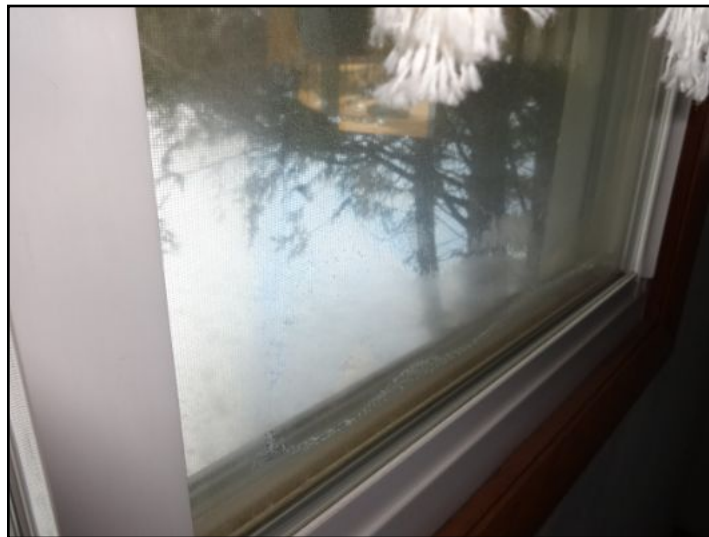
- The window seal or seals appear to have failed. The most common signs that the glass unit has failed are: 1) Condensation is visible between the two (inner and outer) panes of glass. 2) It looks like a white powdery substance is coating the inside of the window. 3) The windows have a foggy appearance. 4) There appears to be a scum on the window that cannot be washed off. Failed seals prevent a cosmetic issue and are difficult to look through as well as lowering the energy efficiency of the window. Recommend considering repair or replacement as needed.
- Screens were missing at the time of the inspection. Recommend consulting the current owner regarding any screens that may be in storage.

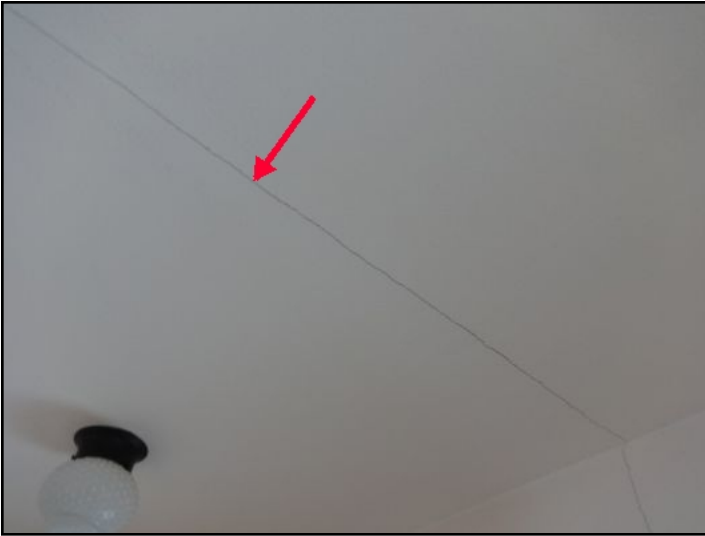
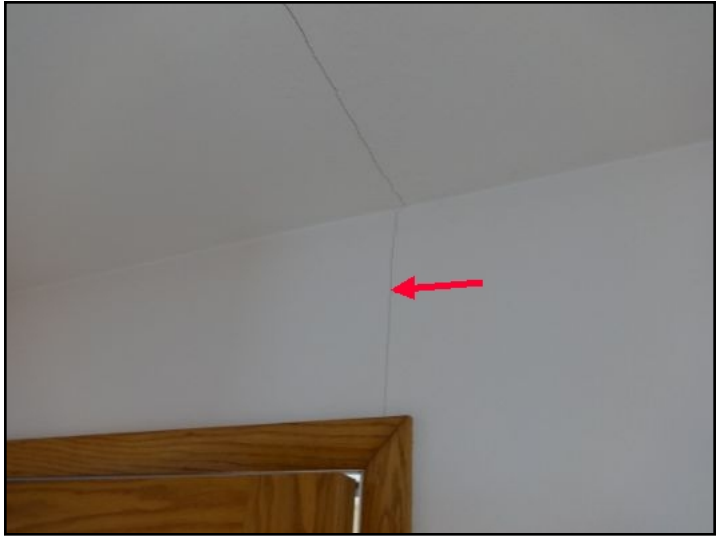
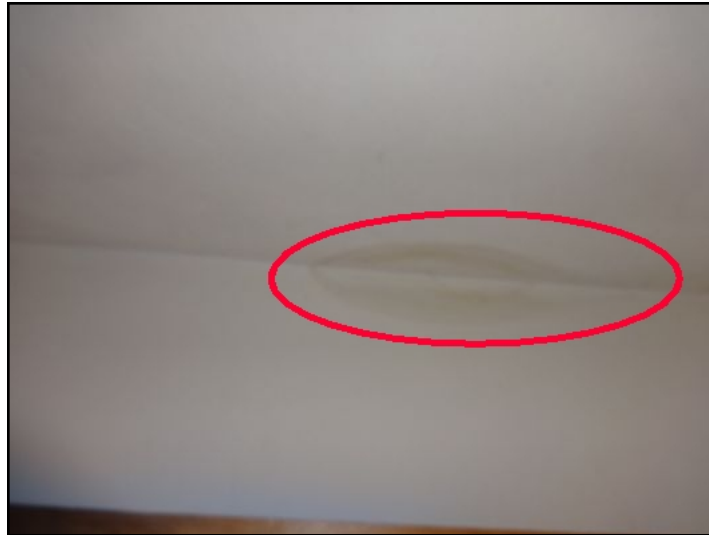
- Cracking in the ceiling was noted. Recommend monitoring for changes or additions. Small cracks are not uncommon, especially if near a cathedral or vaulted ceiling area.
- Apparent water staining was noted. The area appeared dry at the time of the inspection according to a moisture meter. Recommend consulting the current owner for information regarding the stains. Recommend monitoring and if any active leakage is noted, repairing as needed.

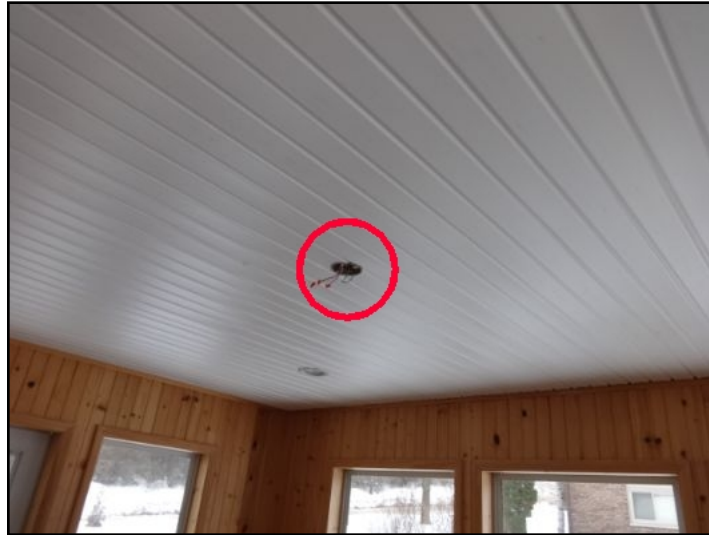
- The ceiling fans appeared to operate properly when tested at time of inspection.
- The ceiling fan in the 3 season room had been removed, leaving the wires hanging. Recommend properly terminating the wires or installing a new fixture.

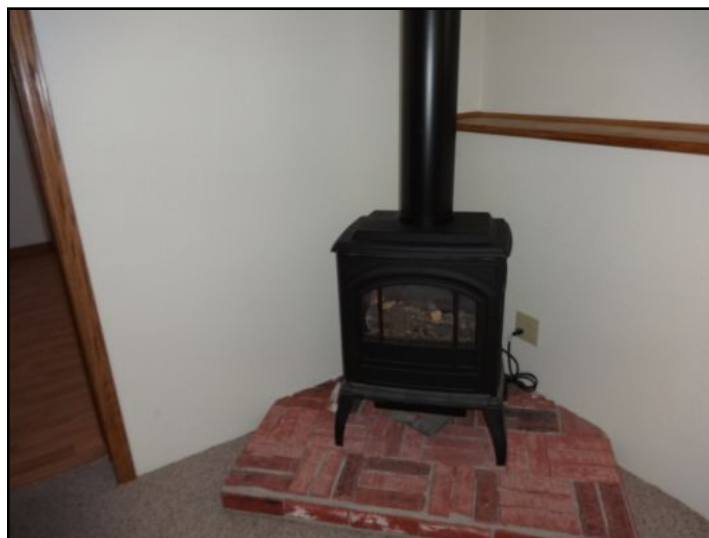
- Recommend the fireplace and chimney is cleaned and inspected by a specialist regularly.

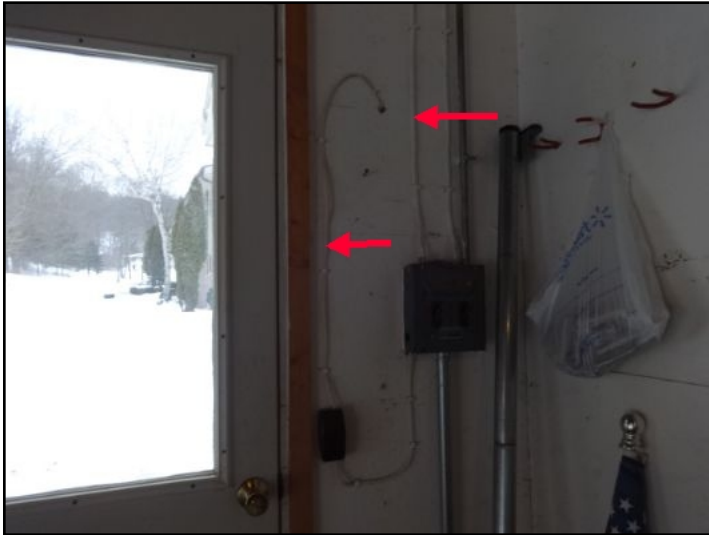
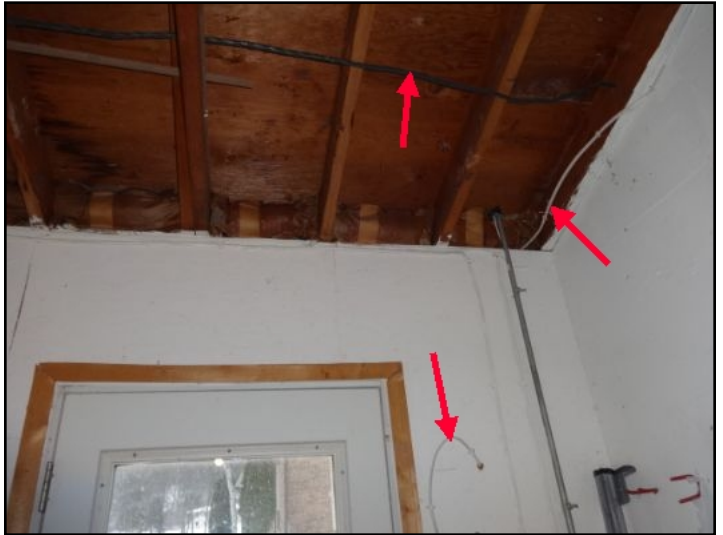
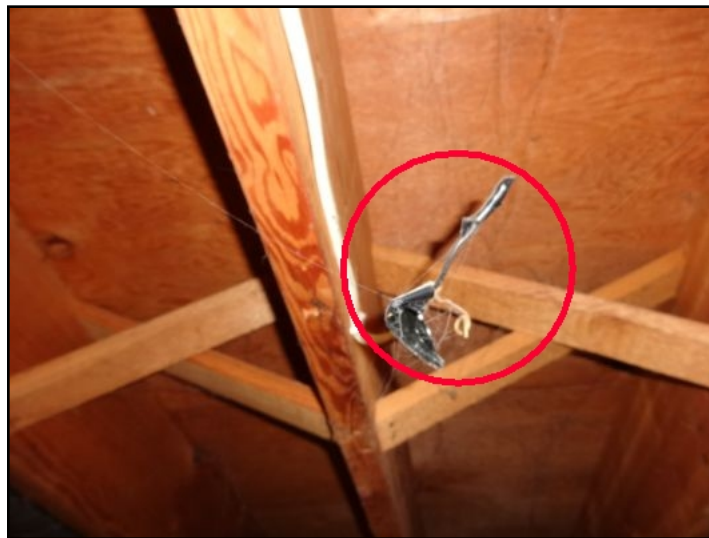
- Improper electrical connections should be repaired. Recommend a proper junction box with a fitted cover.
- Wires that are exposed on the walls, whether interior or exterior, should be relocated within the wall or protected in conduit. Recommend considering improvement.

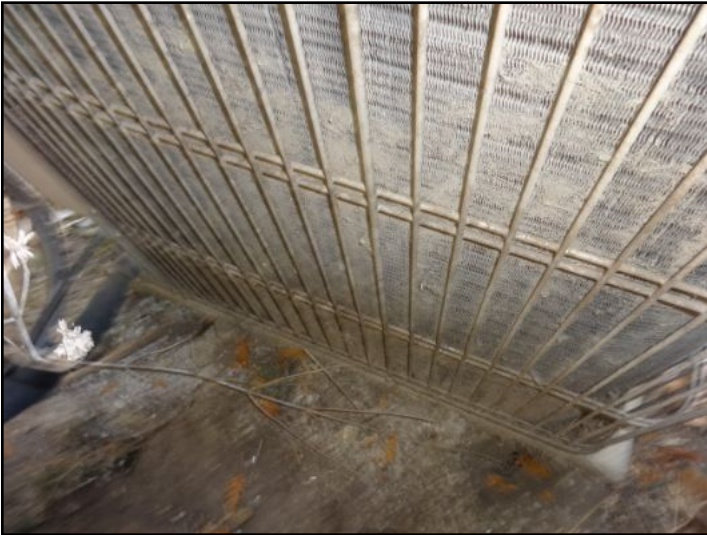
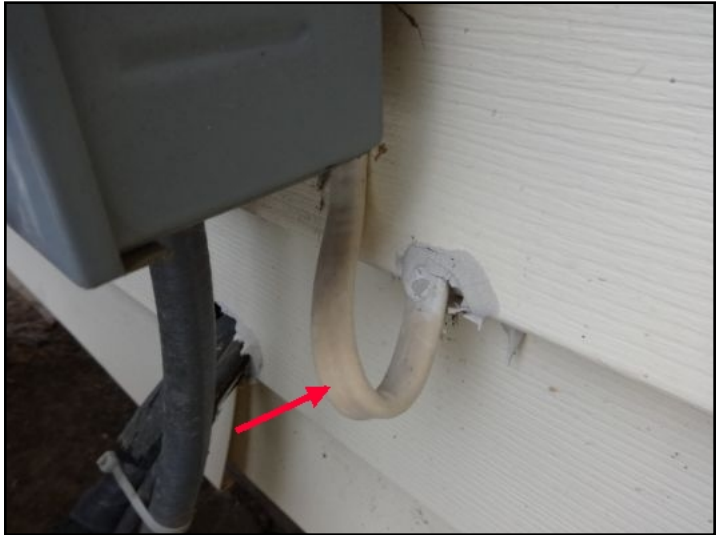
- The outside unit of the air conditioning system was dirty. Recommend cleaning as needed.
- The power wire for the exterior electrical disconnect box was exposed. Recommend repair or replacement as needed.

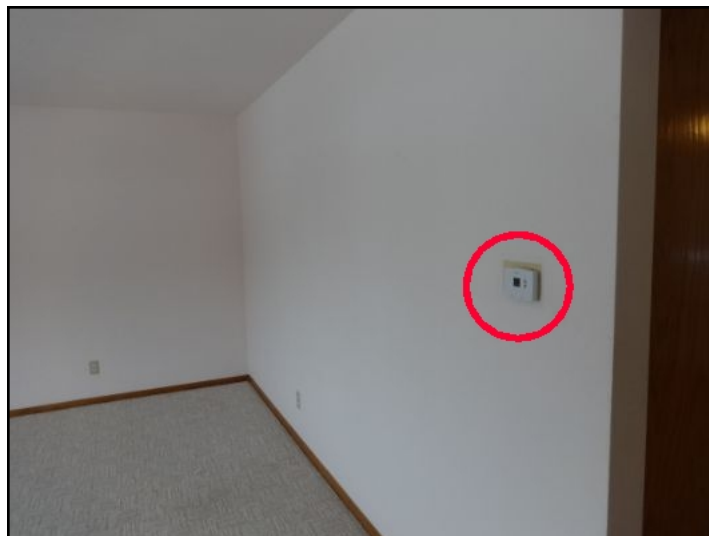
- The thermostat appeared functional at the time of the inspection.

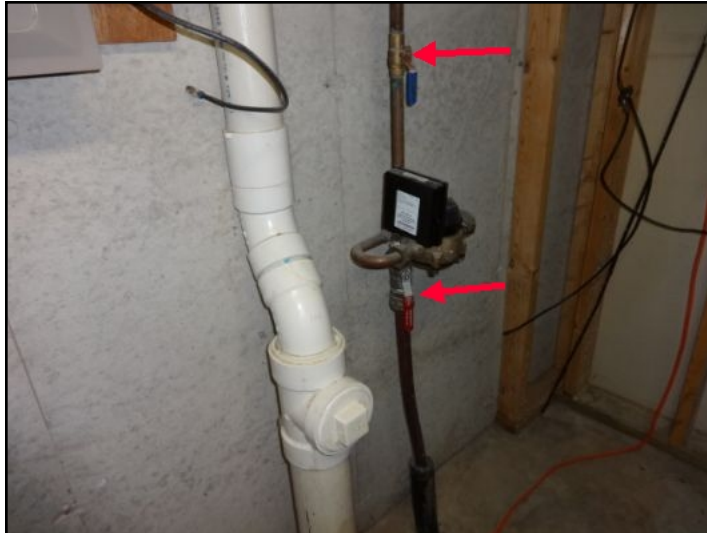
Location: Basement West wall

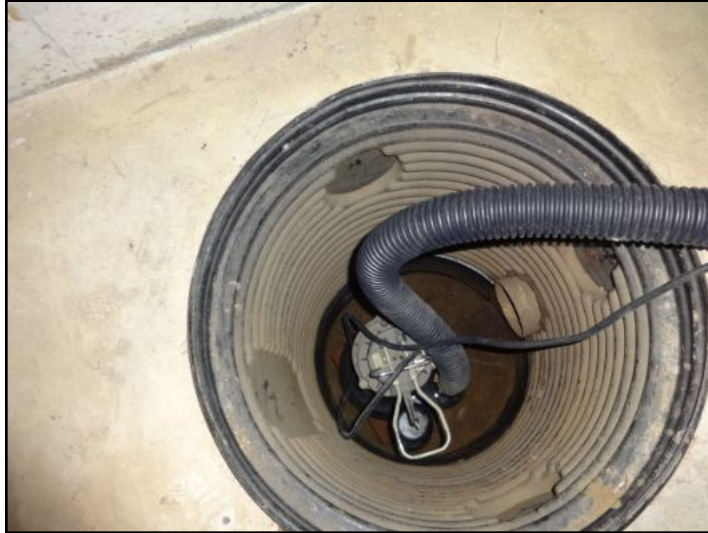
- Sump pump and pit (basin) were noted in the basement. The pump was tested and appeared to run properly at that time. Sump pumps should be tested periodically to try to ensure they are operating properly when needed.
- Recommend a proper cover for the sump pit (basin). During the inspection a trash can lid was used as a cover. Recommend repair as needed.
